Addendum to Data Compilation Task Report for the Source Investigation of the 300-FF-1 Operable Unit Phase 1 Remedial Investigations

January 1991

ADDENDUM TO DATA COMPILATION TASK
REPORT FOR THE SOURCE INVESTIGATION
OF THE 300-FF-1 OPERABLE UNIT PHASE 1
REMEDIAL INVESTIGATIONS

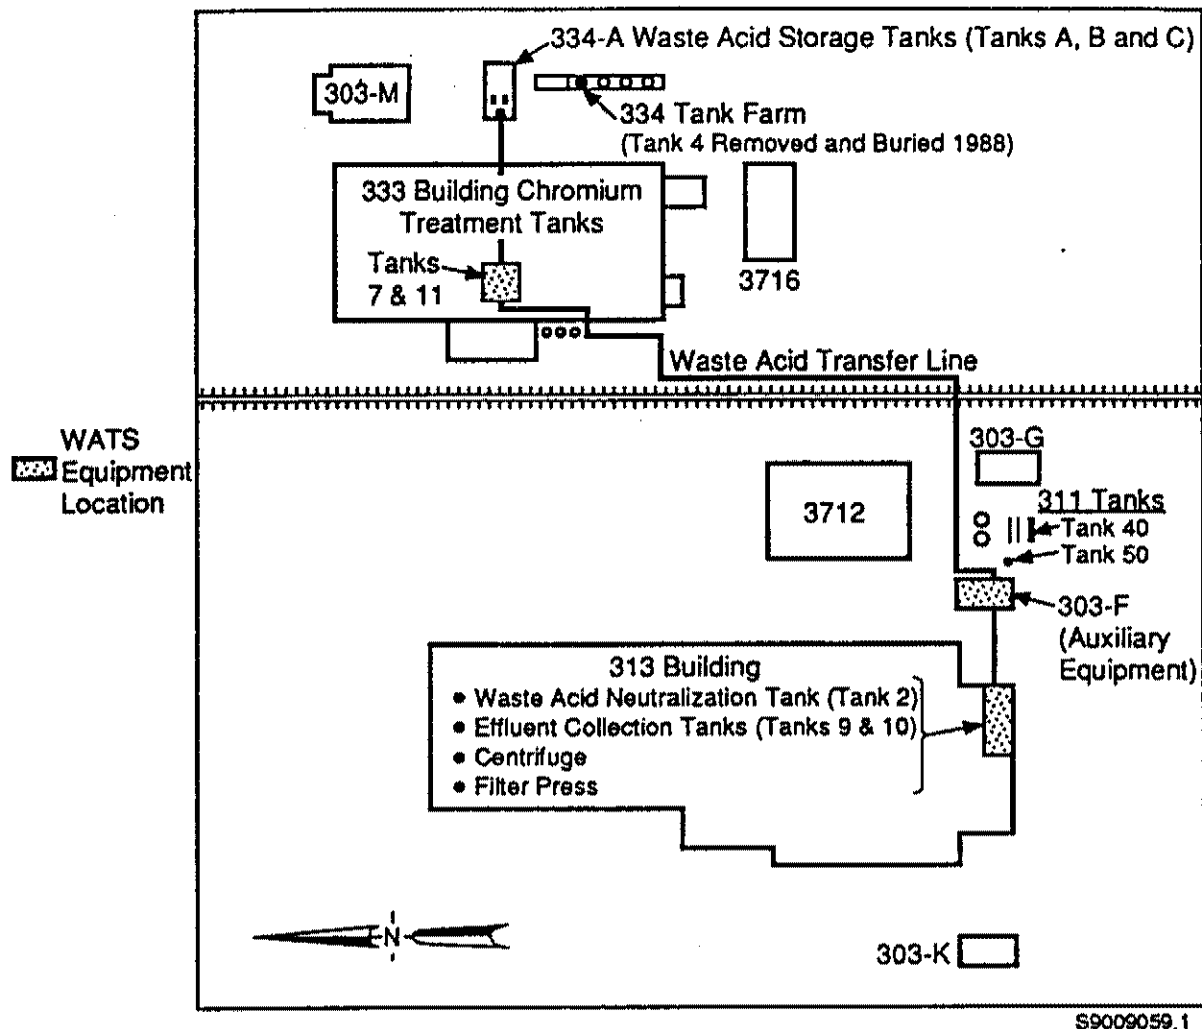
FIGURE 3. 300 Area Waste Acid Treatment System (includes the 311 and 334 Tank Farms)

Both the 311 and 334 Tank Farms were also part of the 300 Area Waste Acid Treatment System (WATS). Acid used in various etching and chemical milling processes was neutralized before being discharged to the Process Sewer. Wastes from other 300 Area operations were also treated in the WATS system. Solids resulting from the treatment operations were removed and

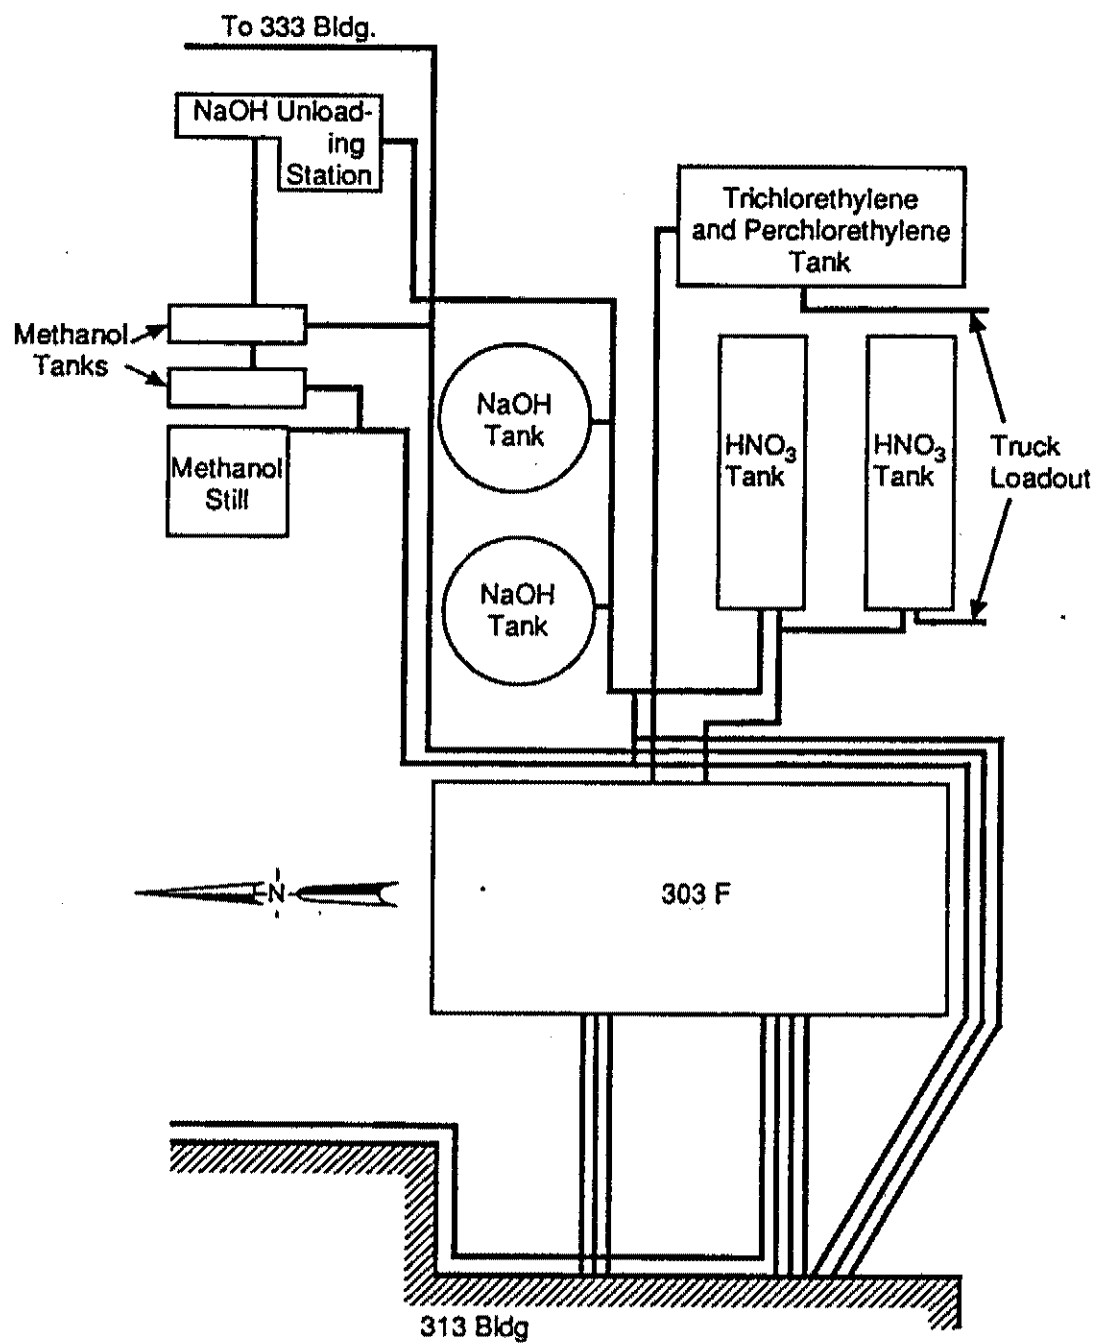
S9009059.2

FIGURE 4. Chemical Pumping and Mixing Facility

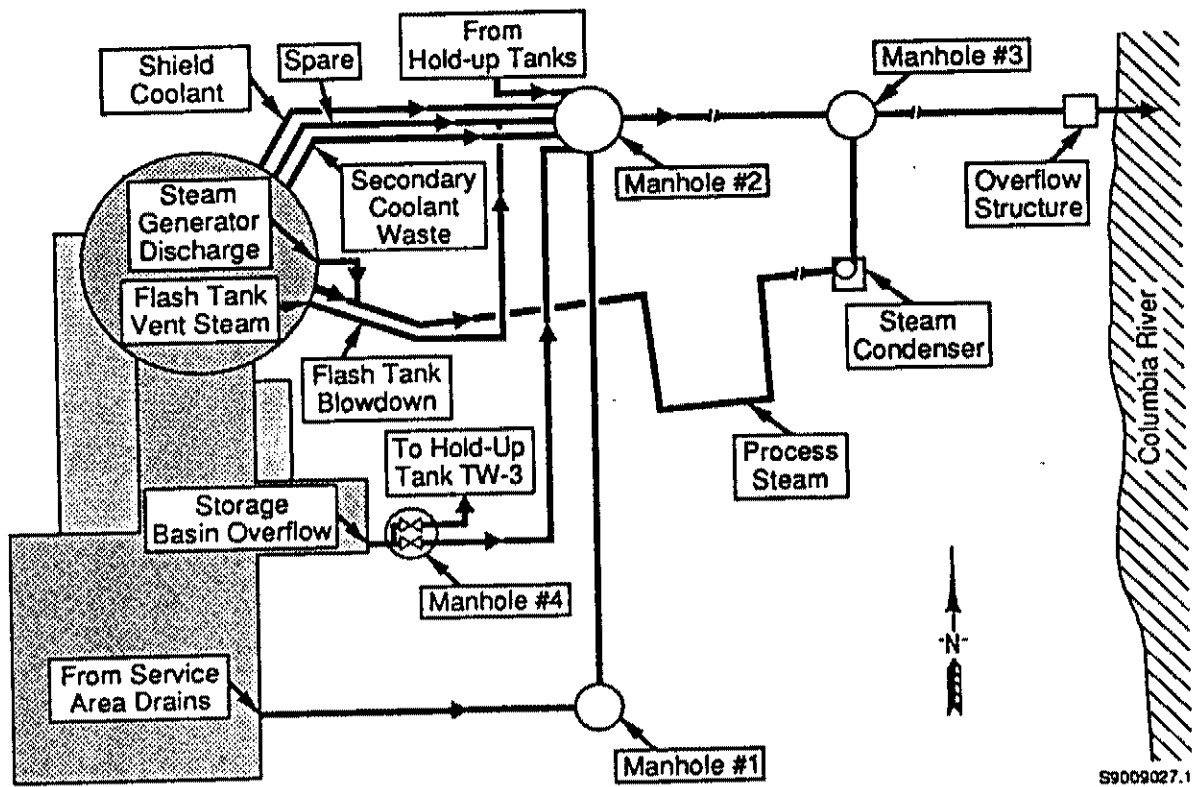
FIGURE 5. PRTR Process Sewer System

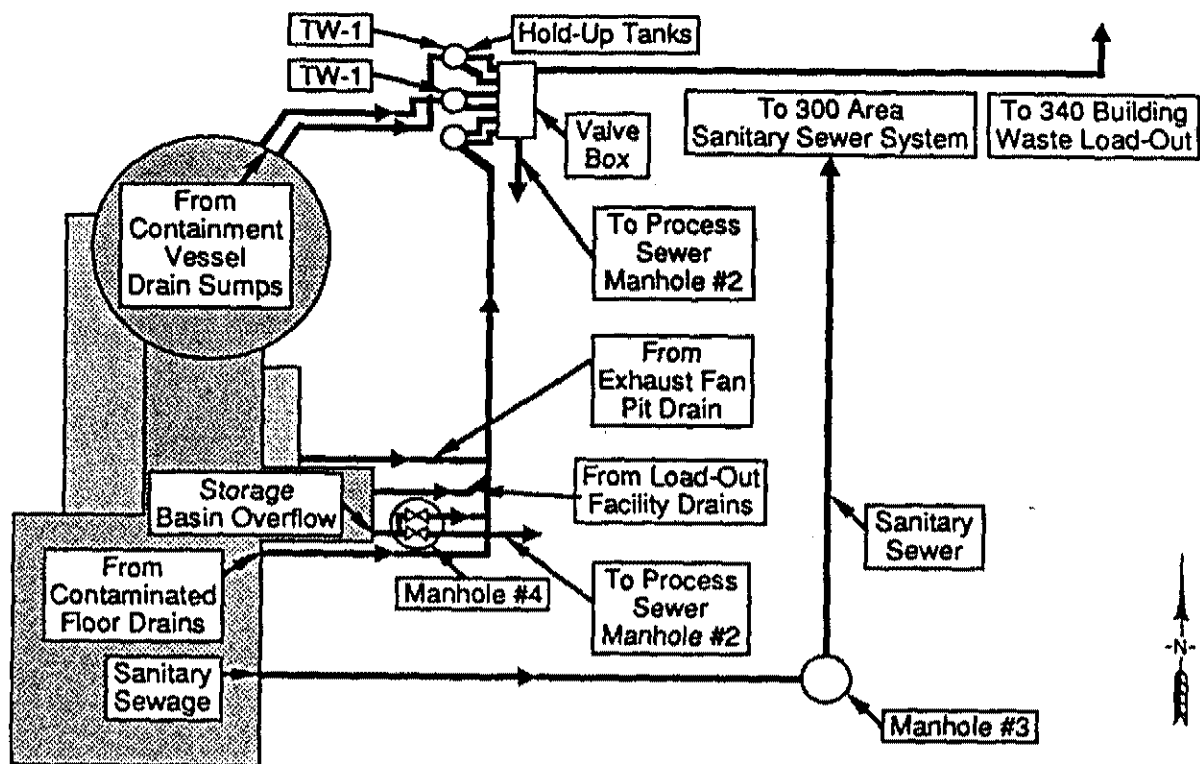
S9009027.2

FIGURE 6. PRTR Contaminated and Sanitary Sewers Process

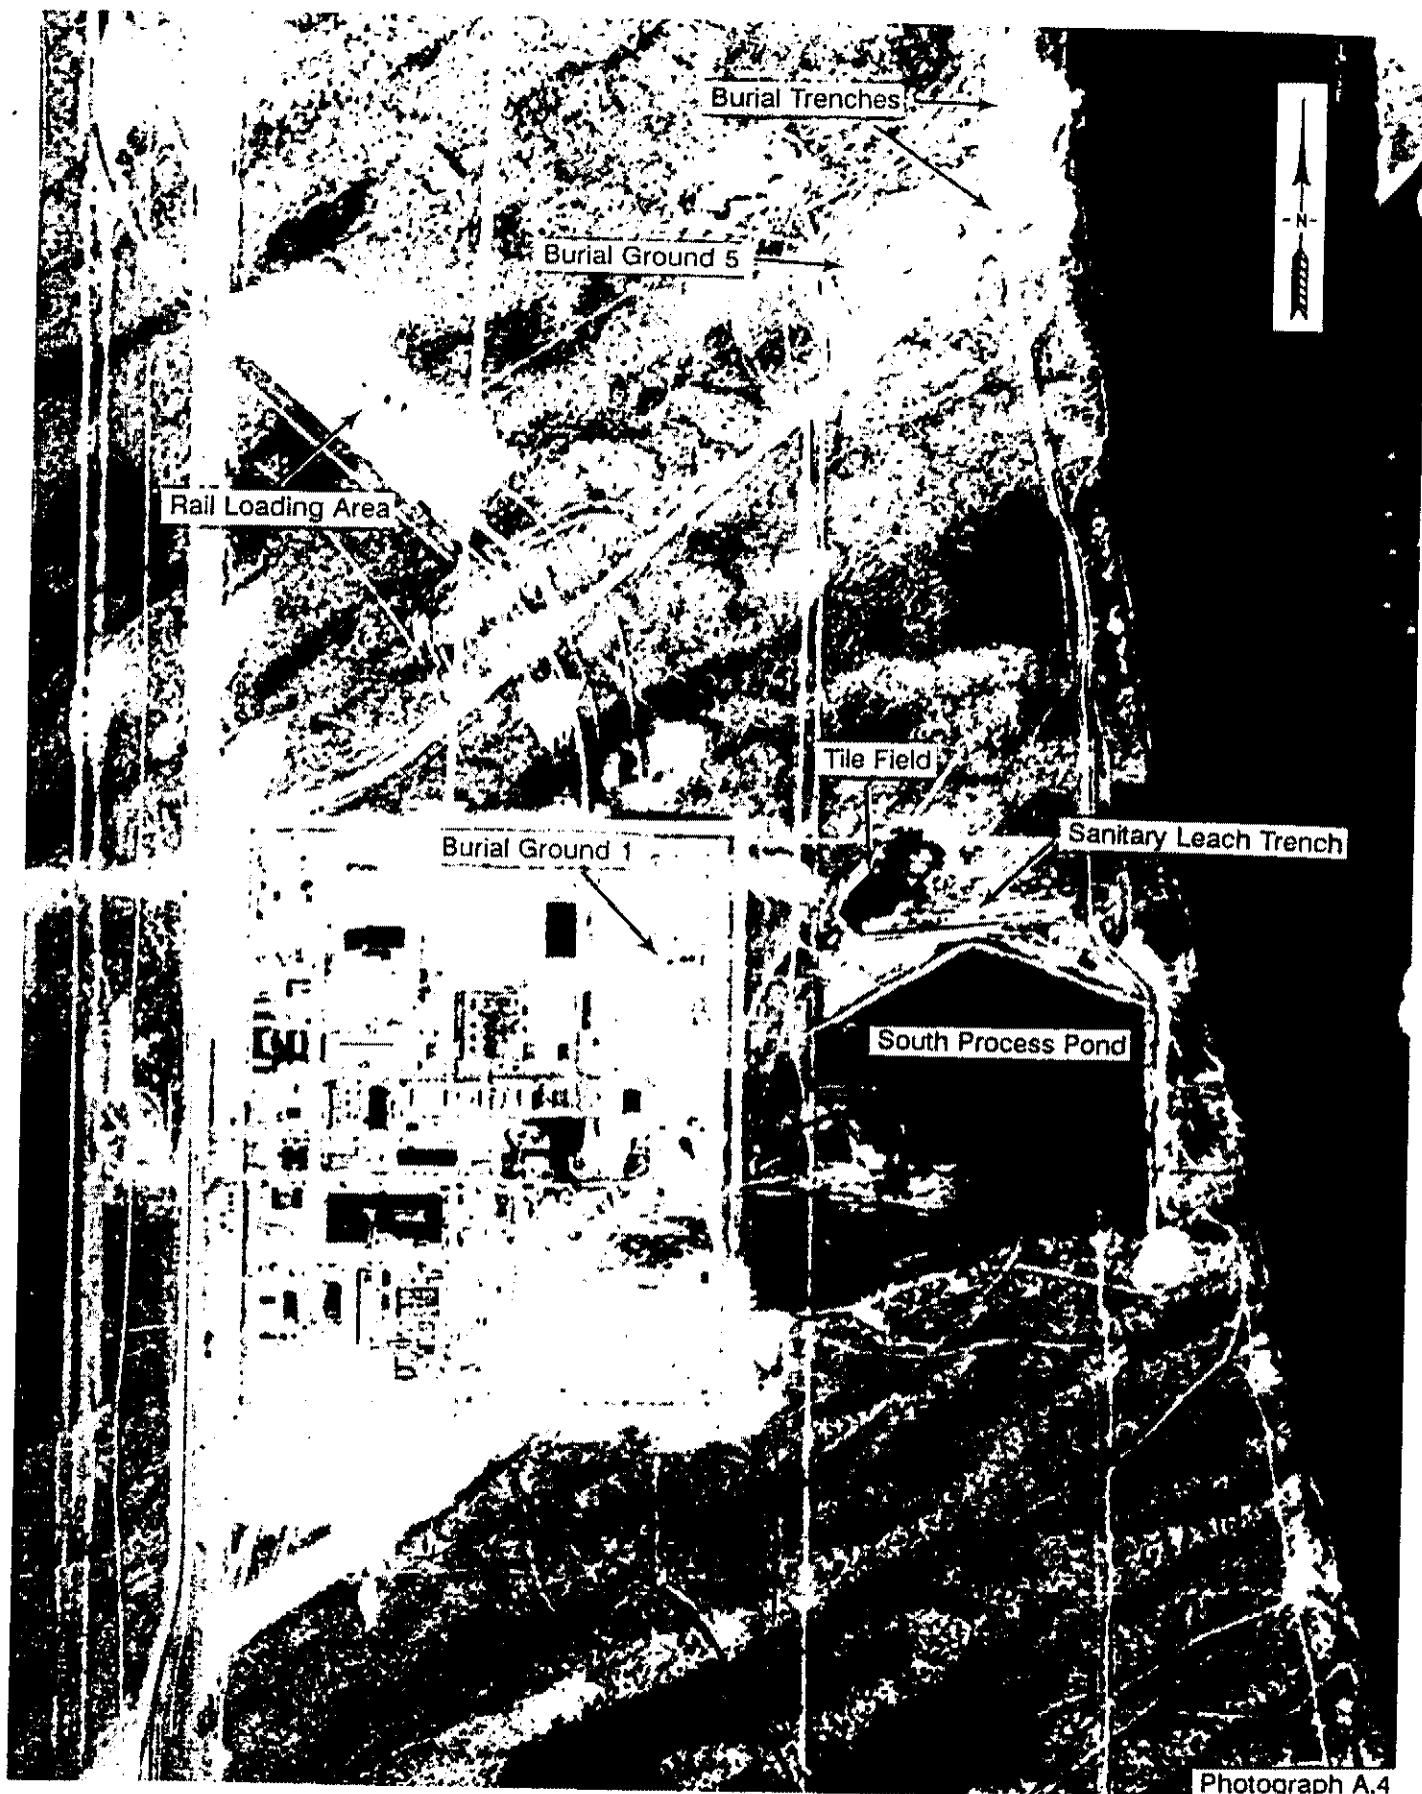
Photograph A.4

PHOTOGRAPH A.4. May 24, 1948. This photograph shows the South Process Pond, the tile field, the first Sanitary Leach Trench, Burial Ground 1 with a pit at the southern end, Burial Ground 5, and burial trenches along the Columbia River. The barren area north of the 300 Area was a rail loading area for aluminum scrap from the 313 Building (Negative No. 90070235-1).

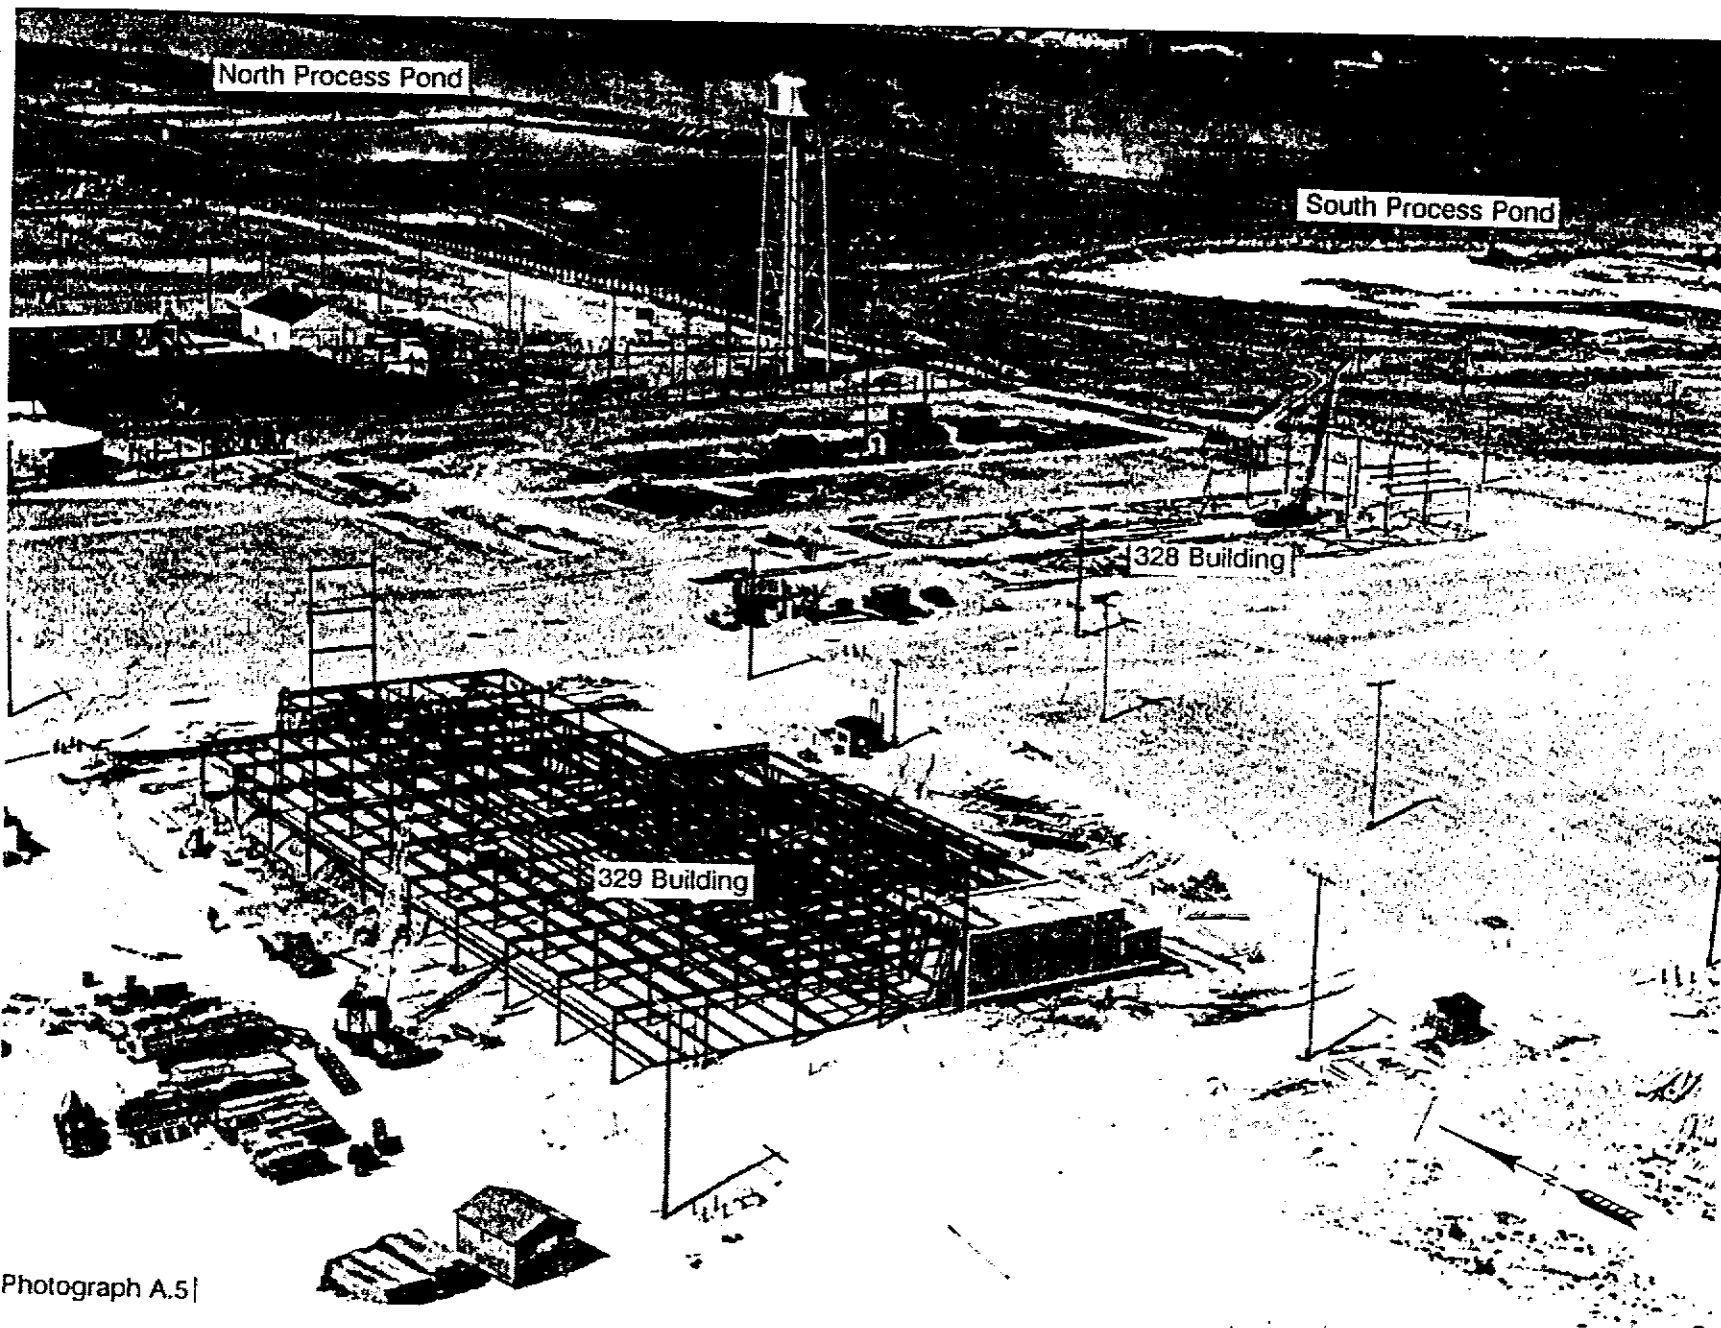
Photograph A.5|

PHOTOGRAPH A.5. May 29, 1951. The South Process Pond (316-1) is drained. The light-shaded sediment is probably aluminum hydroxide that sealed the bottom. New buildings are being framed. In the foreground is the 329 Building. The 328 Building is just beginning to be framed (Negative No. 90061562.2).

This overflow was probably the first indication of reduced infiltration through the pond bottom caused by the accumulation of impermeable precipitates from the dumping of sodium aluminate (Appendix D). Sodium aluminate was a waste product derived from removing the aluminum cladding of rejected fuel assemblies to recover the encapsulated uranium. This decladding process took place in the 313 Building (uranium recovery facility), where the aluminum was dissolved with 15% sodium hydroxide to form sodium aluminate. The sodium aluminate was collected in dumpster truck tanks, and two or three times a week the tanks were hauled to one or the other pond and drained down the dike. This heavy waste, with a specific gravity around 1.5, ran underneath the water in the pond where it gradually became diluted and formed a gelatinous aluminum hydroxide precipitate that plugged the pond bottom, preventing liquid percolation into the soil (Clukey 1954).

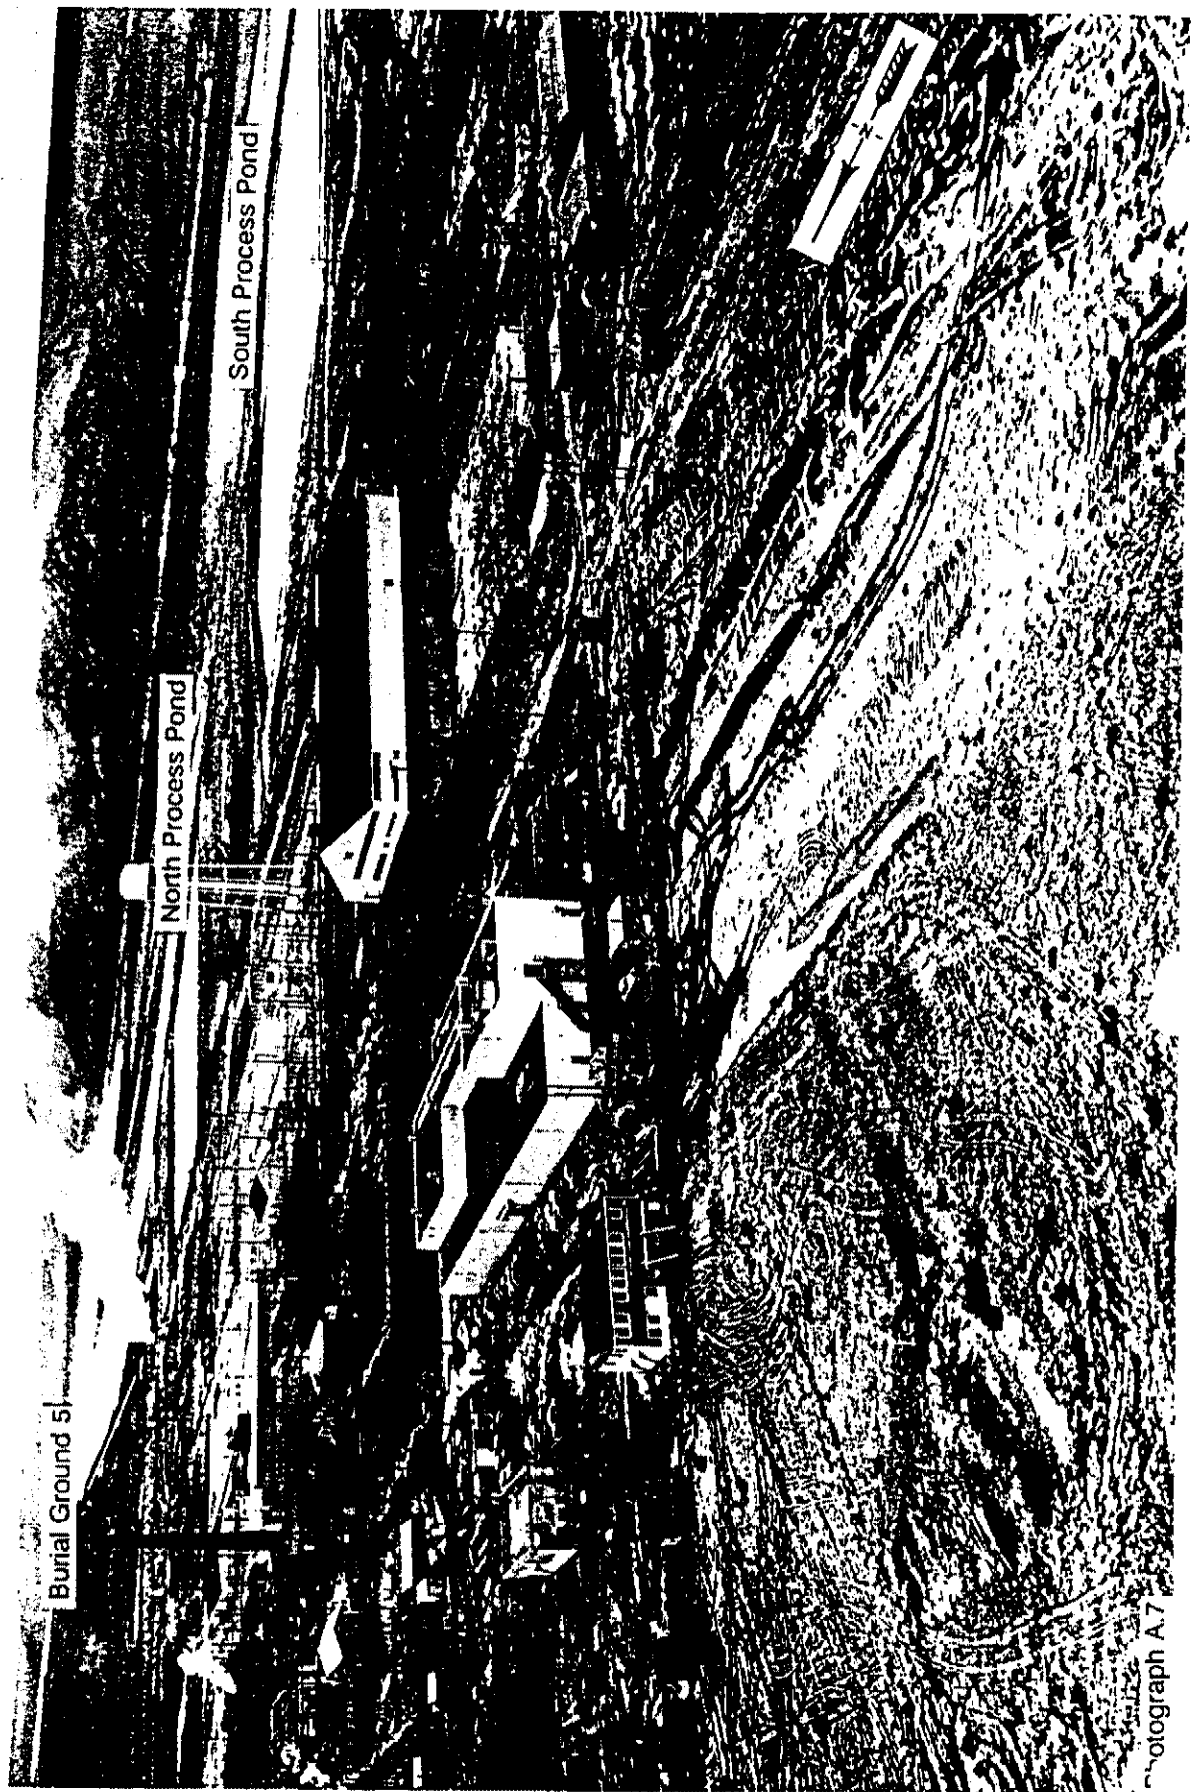
Photograph A.7

PHOTOGRAPH A.7. January 30, 1952. A plume of smoke can be seen in the upper left section of the photograph coming from Burial Ground 5. The North and South Process Ponds were in use (Negative No. 377).

Burial Ground 5 (618-5) was used for the incineration and burial of uranium-contaminated (dose rate <1 mrad/h) and nonradioactive trash collected from the 300 Area (see Photograph A.30). Part of its contents include 17 crucibles contaminated with aluminum-silicon or lead having activity levels <200 mrad/h (Phillips et al. 1980). According to Paas (1955), the pit was covered with about 1 ft of soil on August 28, 1953, and posted as a radiation zone. However, Stenner et al. (1988) report that the site was used as a burial and burning ground until 1962, finally being covered with 4 ft of clean soil. A plume of smoke can be seen coming from the site in Photograph A.7, taken January 30, 1952.

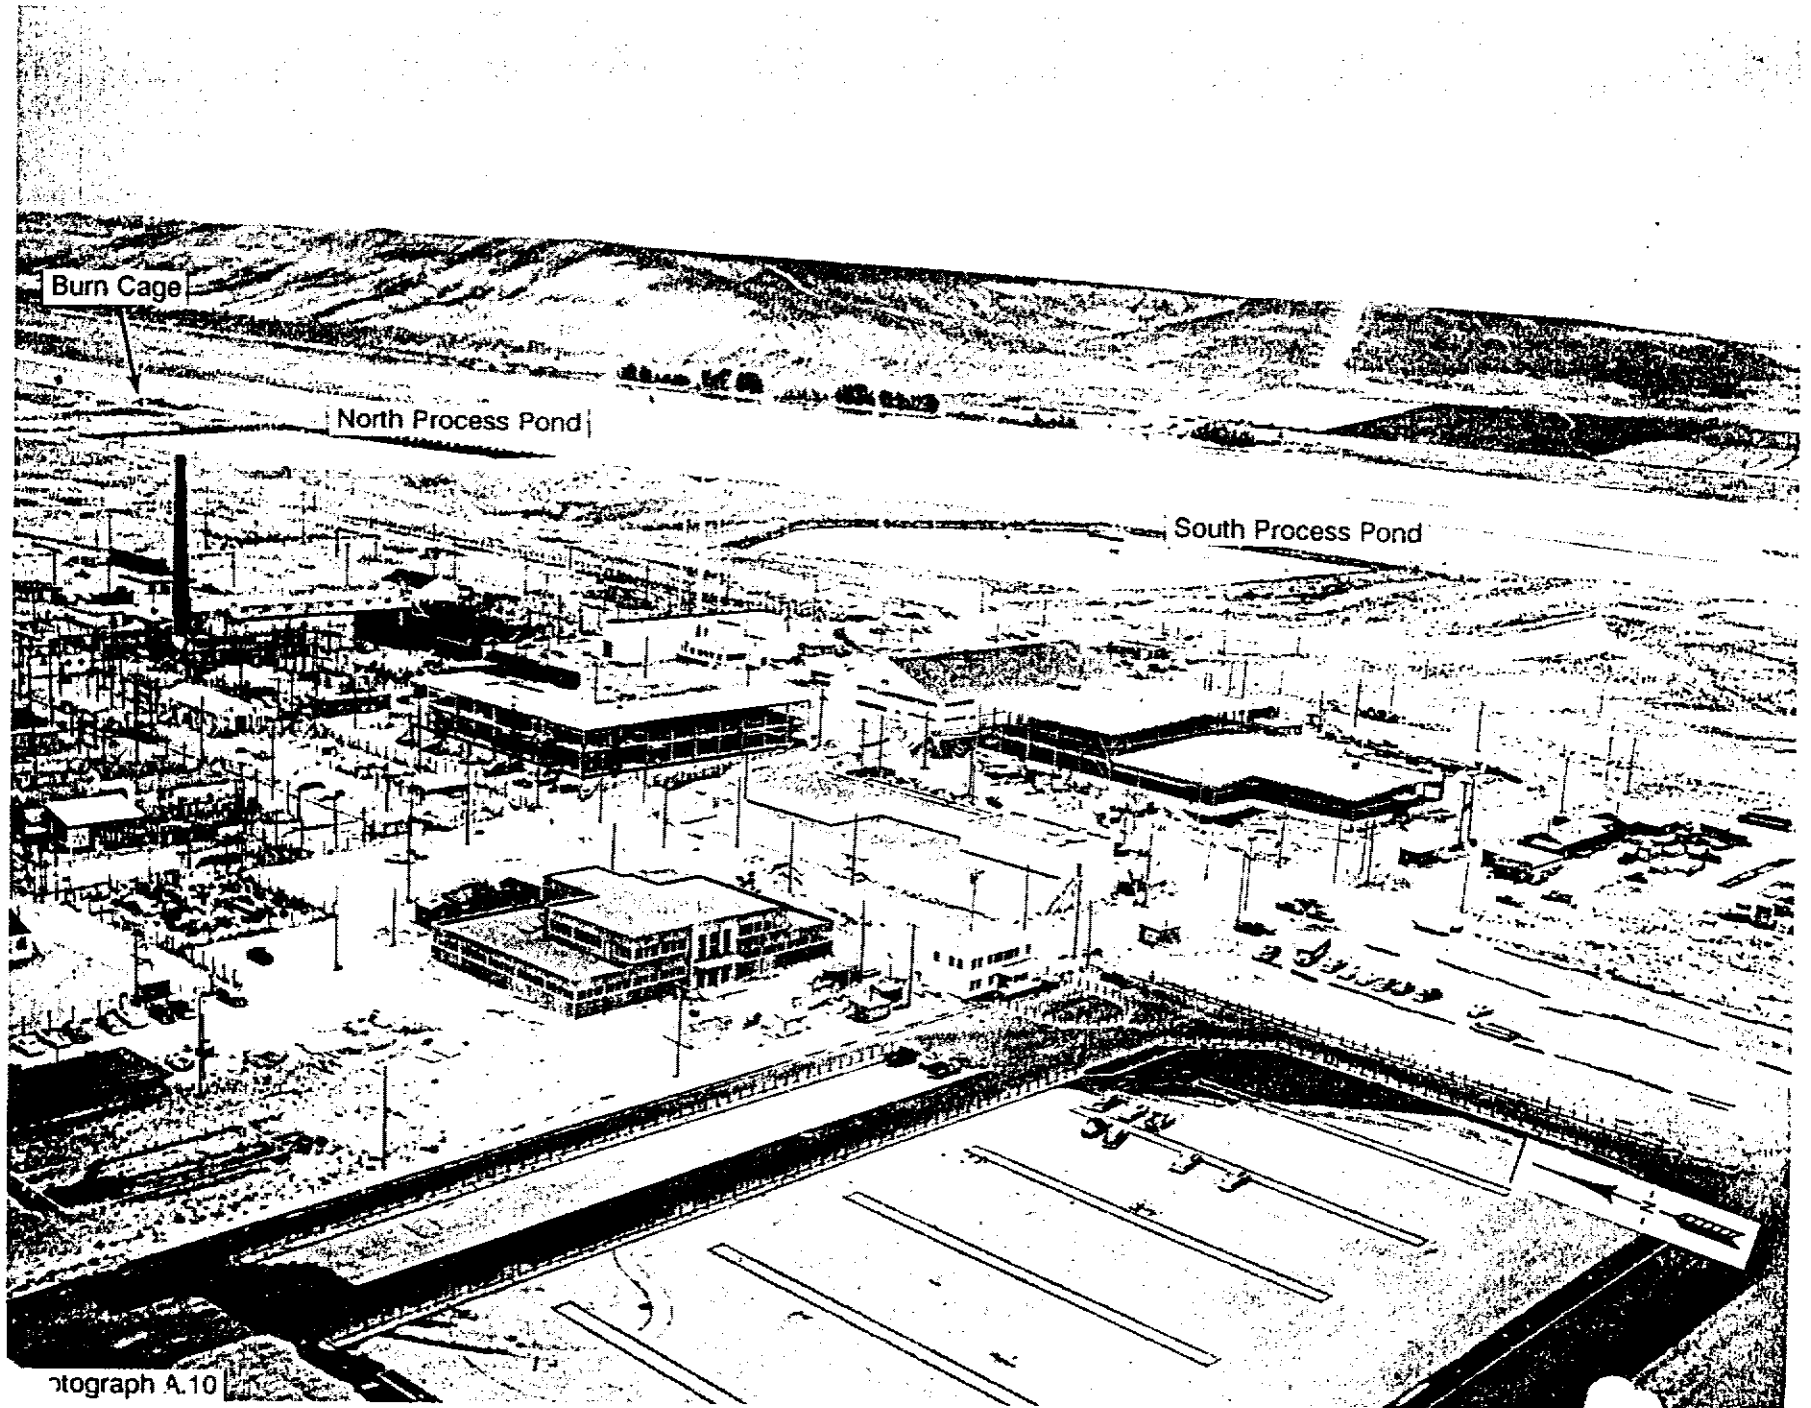
Photograph A.10

PHOTOGRAPH A.10. July 31, 1952. Both Process Ponds are full. The burn cage can be seen north of the North Process Pond. (Negative No. 449).

By 1951 and possibly earlier, paper and other building waste were burned in a steel mesh cage directly east of Burial Ground 5, close to the river (Photograph A.10). The cage still exists today (Photograph A.39). Teel and Olsen (1990) included as part of a surface radiation survey of 300-FF-1 the area around the cage and found numerous contaminated sites with debris ranging from steel drums to laboratory equipment (Photograph A.40). Photographs A.4, A.11, A.14, and A.17, taken between 1948 and 1956, indicate

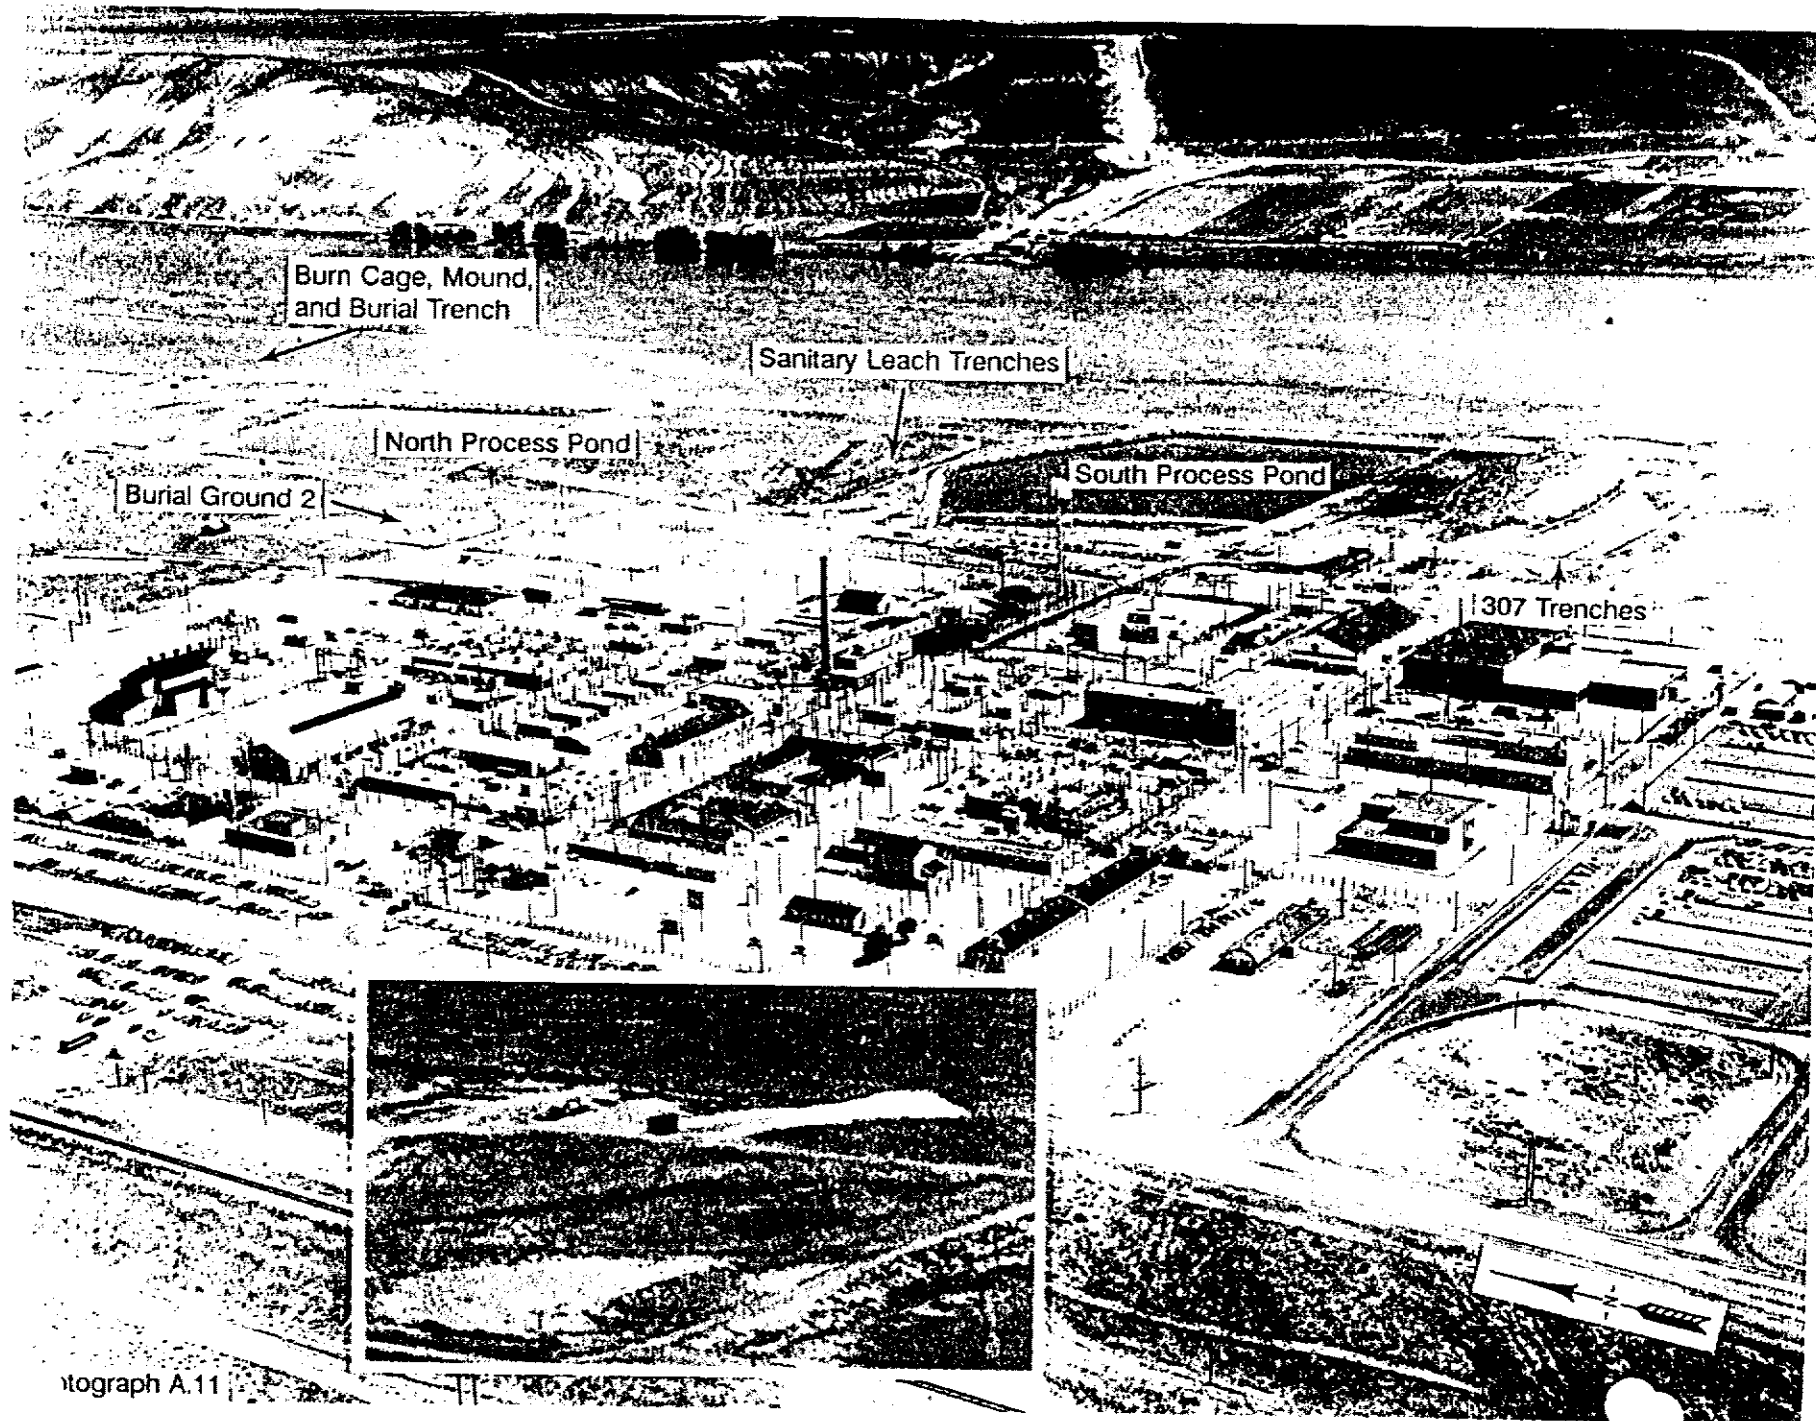
Photograph A.11

PHOTOGRAPH A.11. June 8, 1953. In front of the North Process Pond is Burial Ground 2 (618-2). Behind the burn cage, near the edge of the Columbia River, is a newly constructed mound (see enlarged insert). This mound still exists, and protruding from it are concrete rubble, pipes, iron bars, and barrels. Just to the north of the burn cage is a burial trench (Negative No. 2052).

Burial Ground 2 (618-2) can be seen in Photograph A.11. It contains uranium waste such as solid metallic oxides in the form of metal cuttings, uranium-contaminated equipment, plutonium, and fission products. Burial Grounds 1 and 2 also contain large amounts (tons) of tin from the triple dip canning process and lead from the lead-dip process. Burial Ground 2 was decommissioned in 1954, replaced by Burial Ground 3. tin
lead

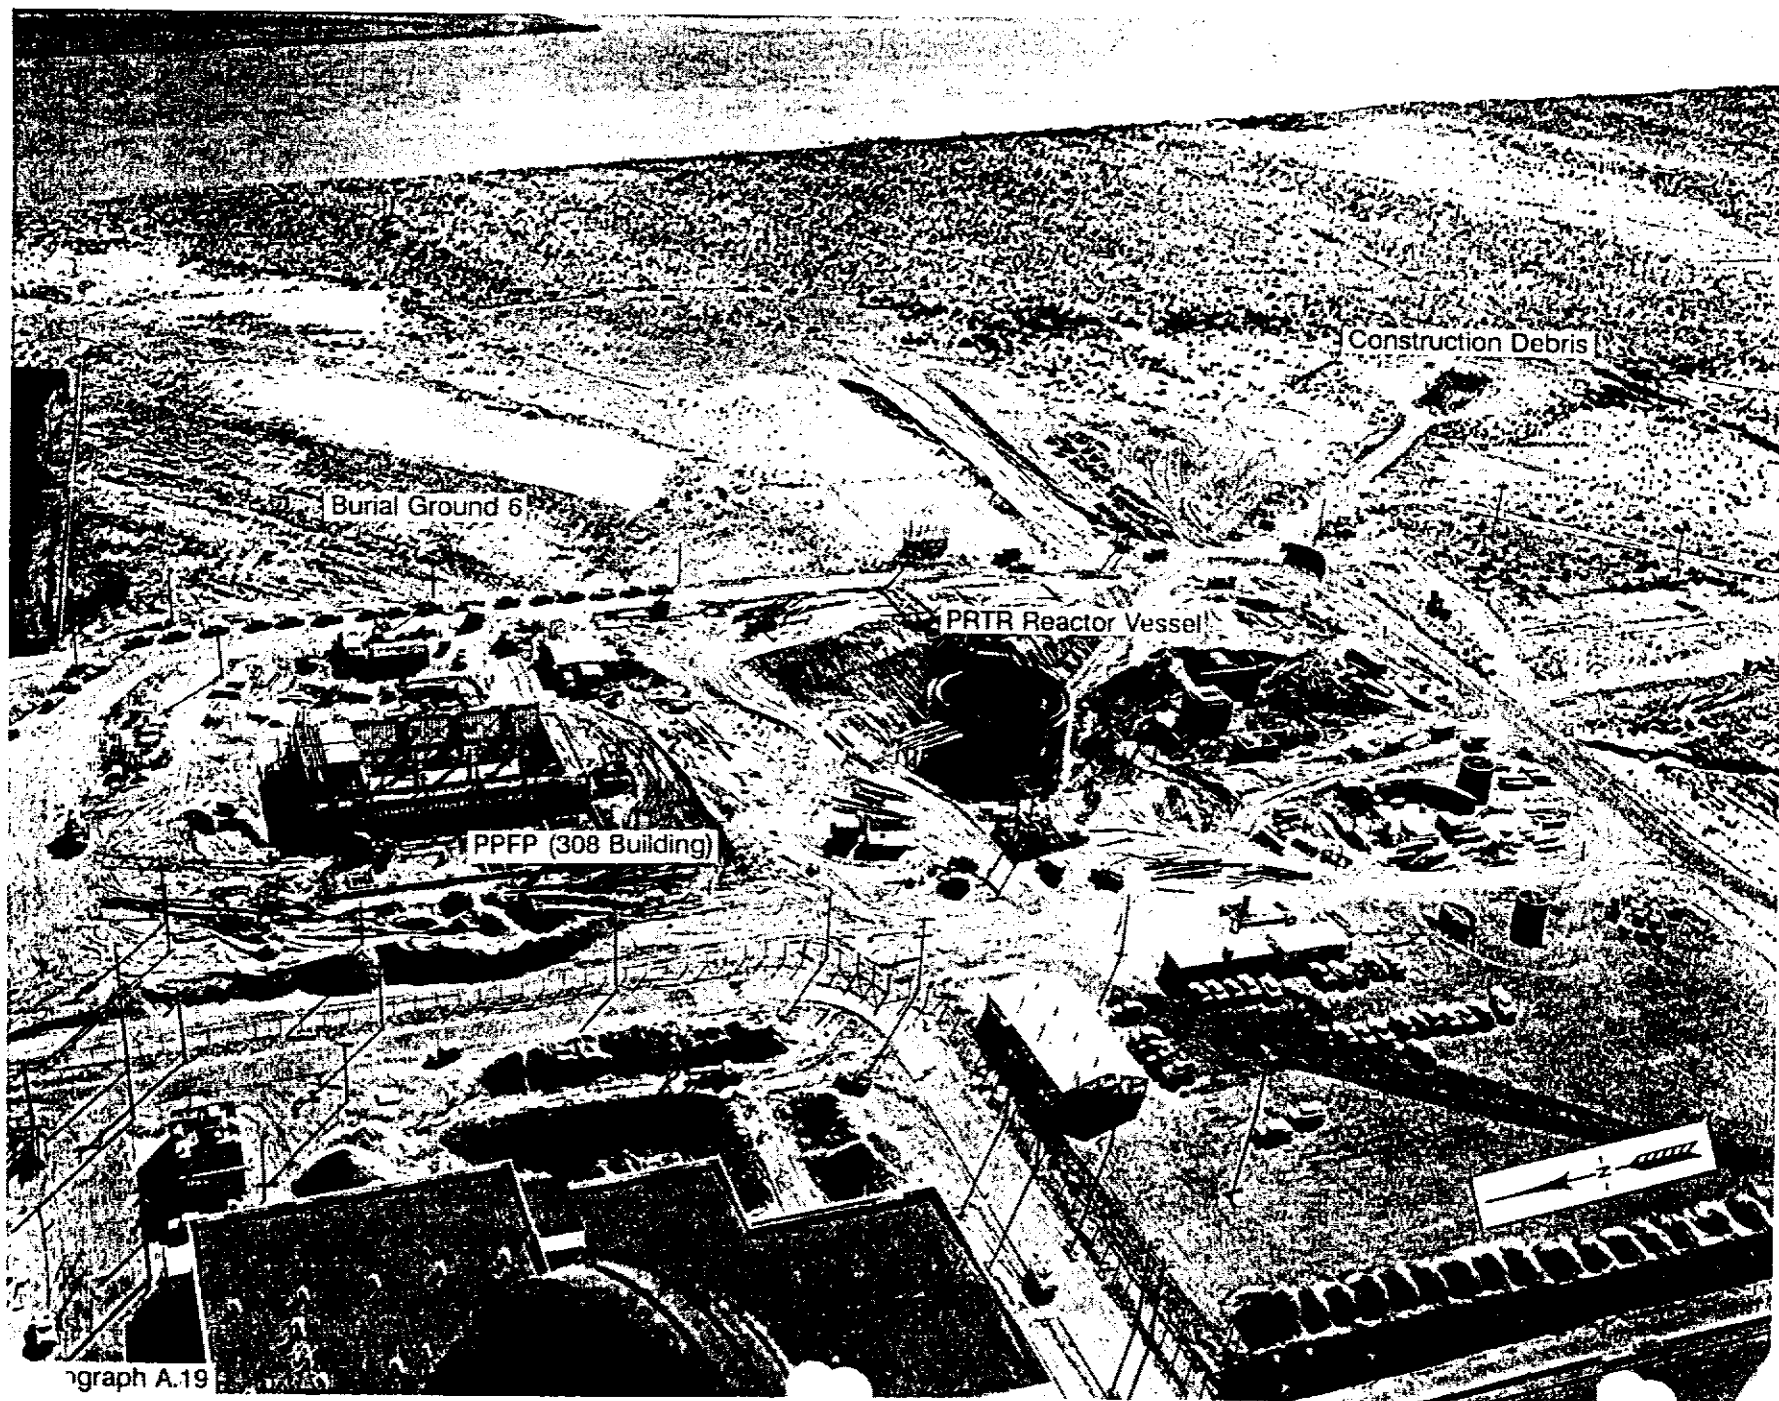
Graph A.19

PHOTOGRAPH A.19. September 30, 1958. Under construction are the PRTR reactor vessel and the PFPP (308 Building). In the upper right portion of the photograph is a burial pit for construction debris. This pit contains no radioactive material. The fenced area east of the PFPP is Burial Ground 6 (Negative No. 5342).

A burial pit to the southeast of the facilities, outside 300-FF-1, was used for construction rubble (Photograph A.19). The pit was covered over sometime in the late 1960s.
